**SCHOOL OF BUILDING AND ENVIRONMENT  
DEPARTMENT OF ARCHITECTURE  
M. Arch (Sustainable Architecture)**

**PROFESSIONAL TRAINING (S89APT)  
JUL 2022 - AUG 2022**

Industrial plant @ IIT, Tirupati

# Residence @ Velachery

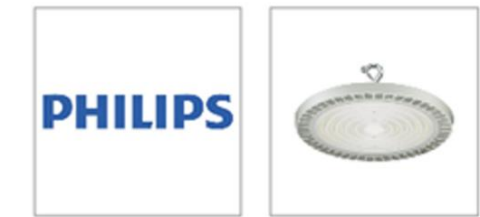
Philips - BY101P LED210S/840 WB PS

## Space - Production line

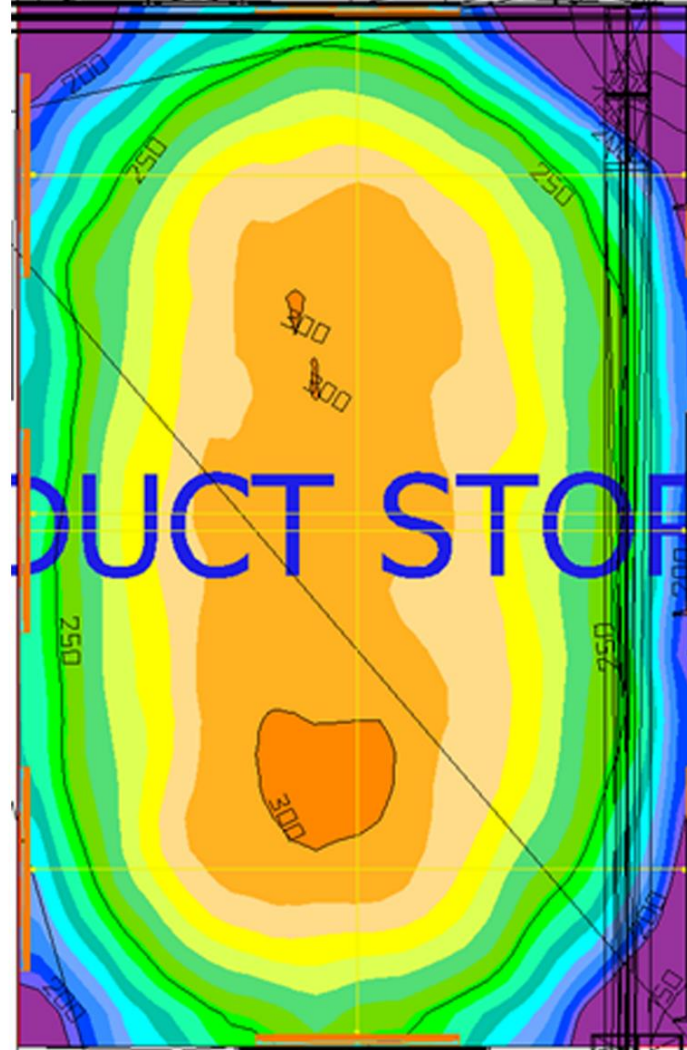
The product storage room has tubelights placed on the walls @ mounting height of 2400mm from FFL.

The luminaires that are placed almost evenly spread out it does the work of spreading out the light.  
The luminaires are placed on walls.as shown in the luminaire layout.

Overall of illuminance of work plane E- 259 lux within the required standard of minimum

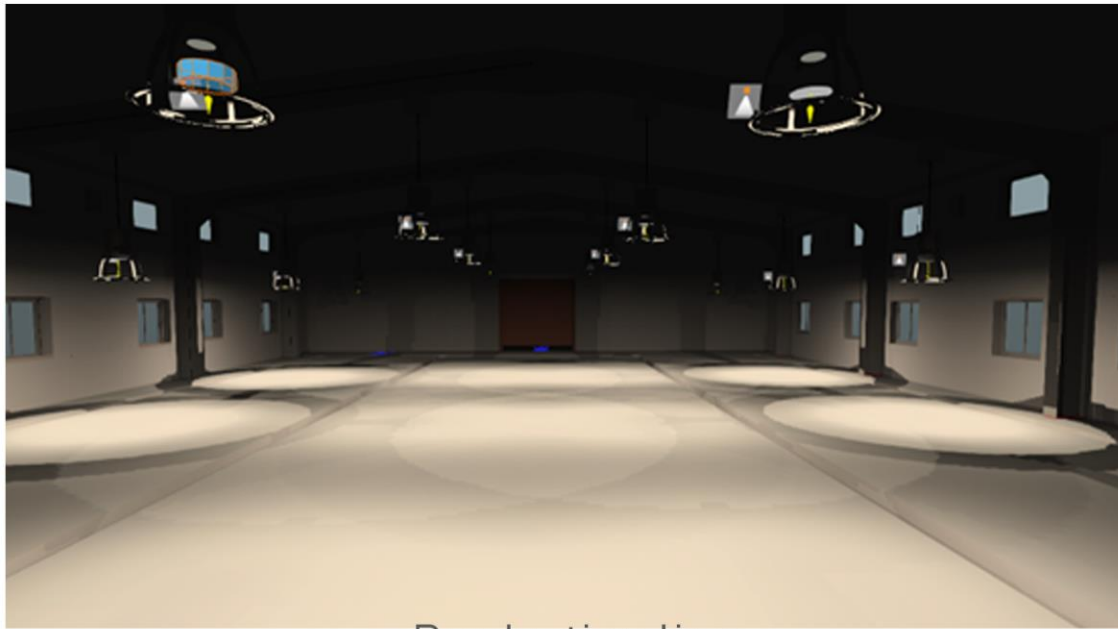
Production line

| | Symbol | Calculated | Target | Check | Index |
|---|---|---|---|---|---|
| Room | Lighting power density | 5.84 W/m <sup>2</sup> | - | - | |
| | | 2.25 W/m <sup>2</sup> /100 lx | - | - | |

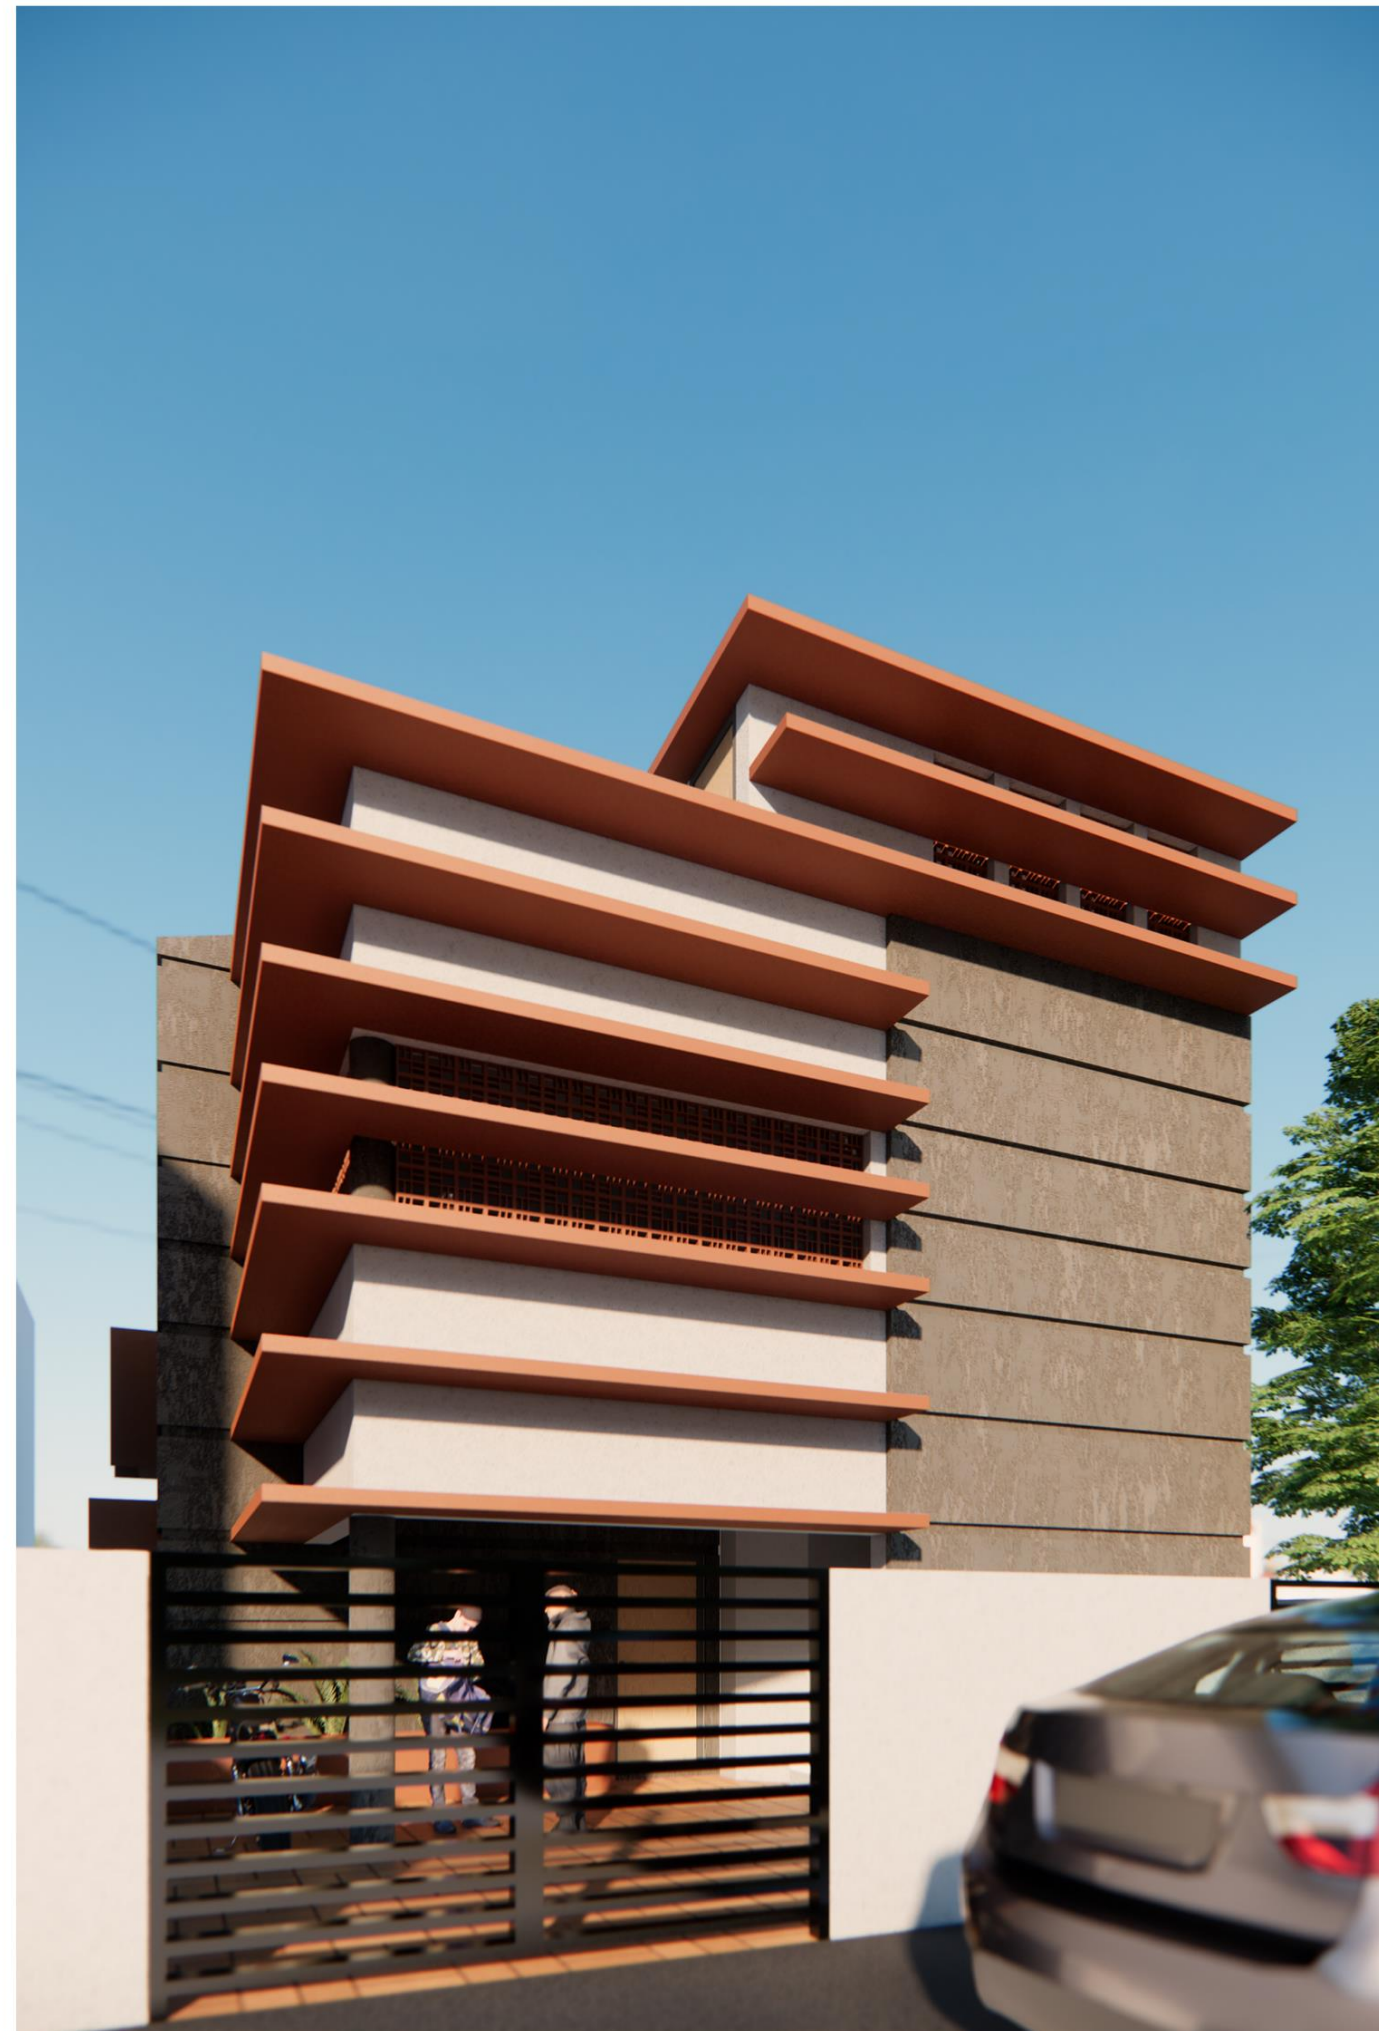
### SOUTH

Jalli works on the facade complement the colour scheme and material finish in the elevation and also provide interesting shadow patterns after 4pm in the interiors.

Horizontal grooves creates a sense of continuity on the concrete finish and does not make it look different and stand out instead combines it as a whole.

VSA – 55deg. and HSA 50deg.  
Covers most of the direct solar radiation that enters into the building .  
Reduces glare and heat gain.

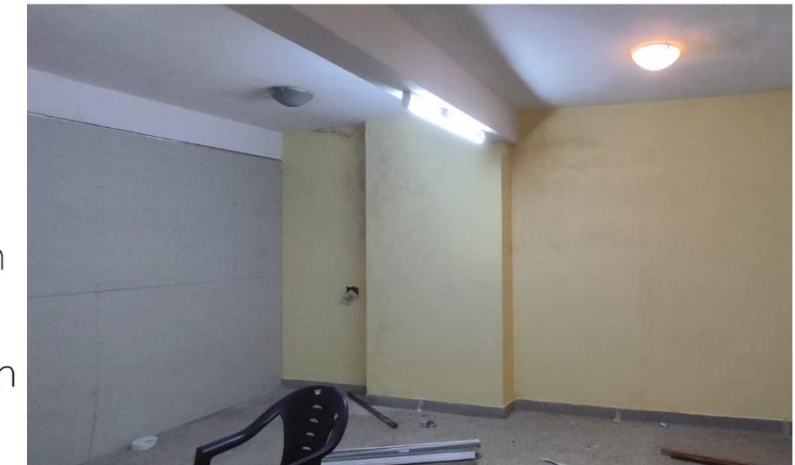
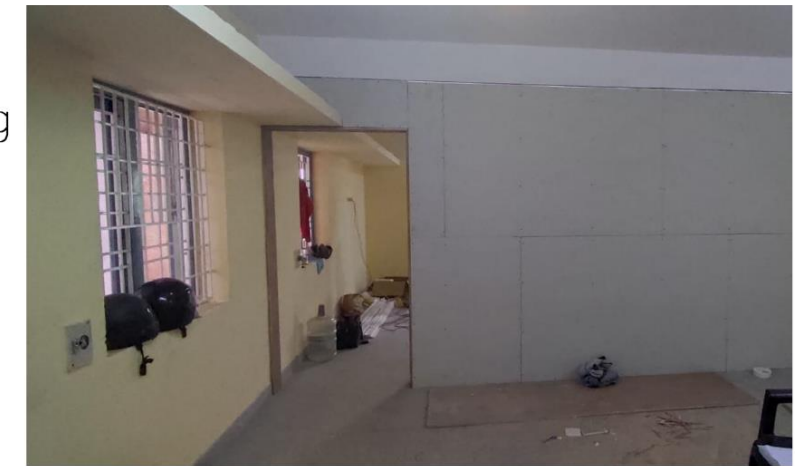
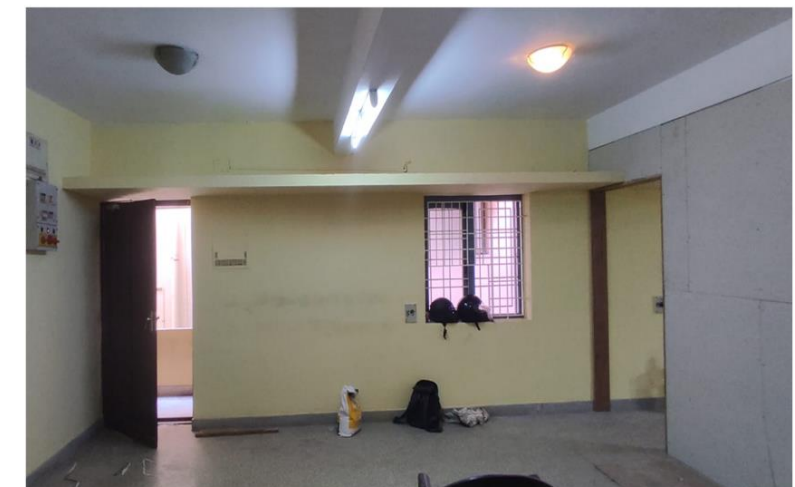
1. Partition glass from next door office is removed and refixed along with sliding door for access.
2. Light weight partition with appropriate finish to be added above the partition glass to support the glass.

There was an existing office nearby that was to be shifted to this place. So most of the lighting fixtures, furnitures and interior materials were taken up, upscaled and reused in the new proposal given.
